## **FAX TRANSMITTAL**

**Subject** Horton Drivemaster 989012/999012

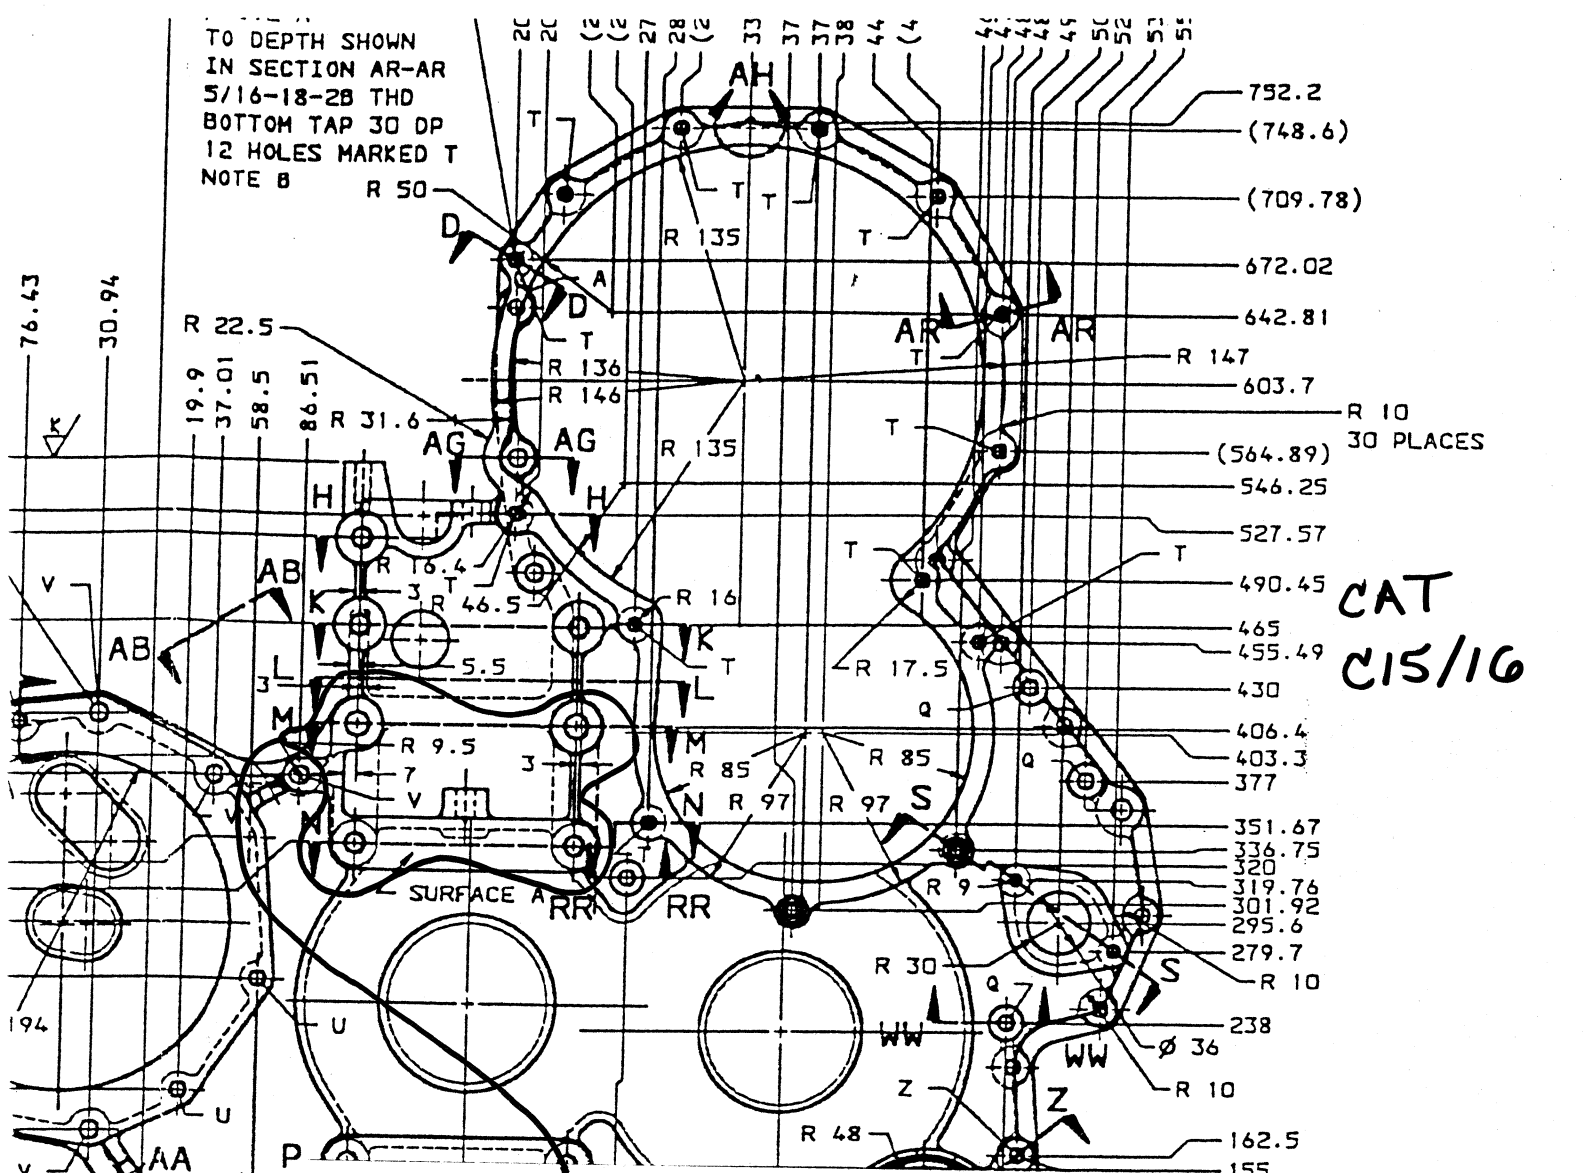
OLD MOUNTING  
 LOCATION  
 FOR HORTON 999012

DriveMaster 999012's built before Serial # 2790699 use the old bracket; therefore, replacement with current production 999012's requires relocating the engine-mounting studs. (See accompanying drawings for clarification)

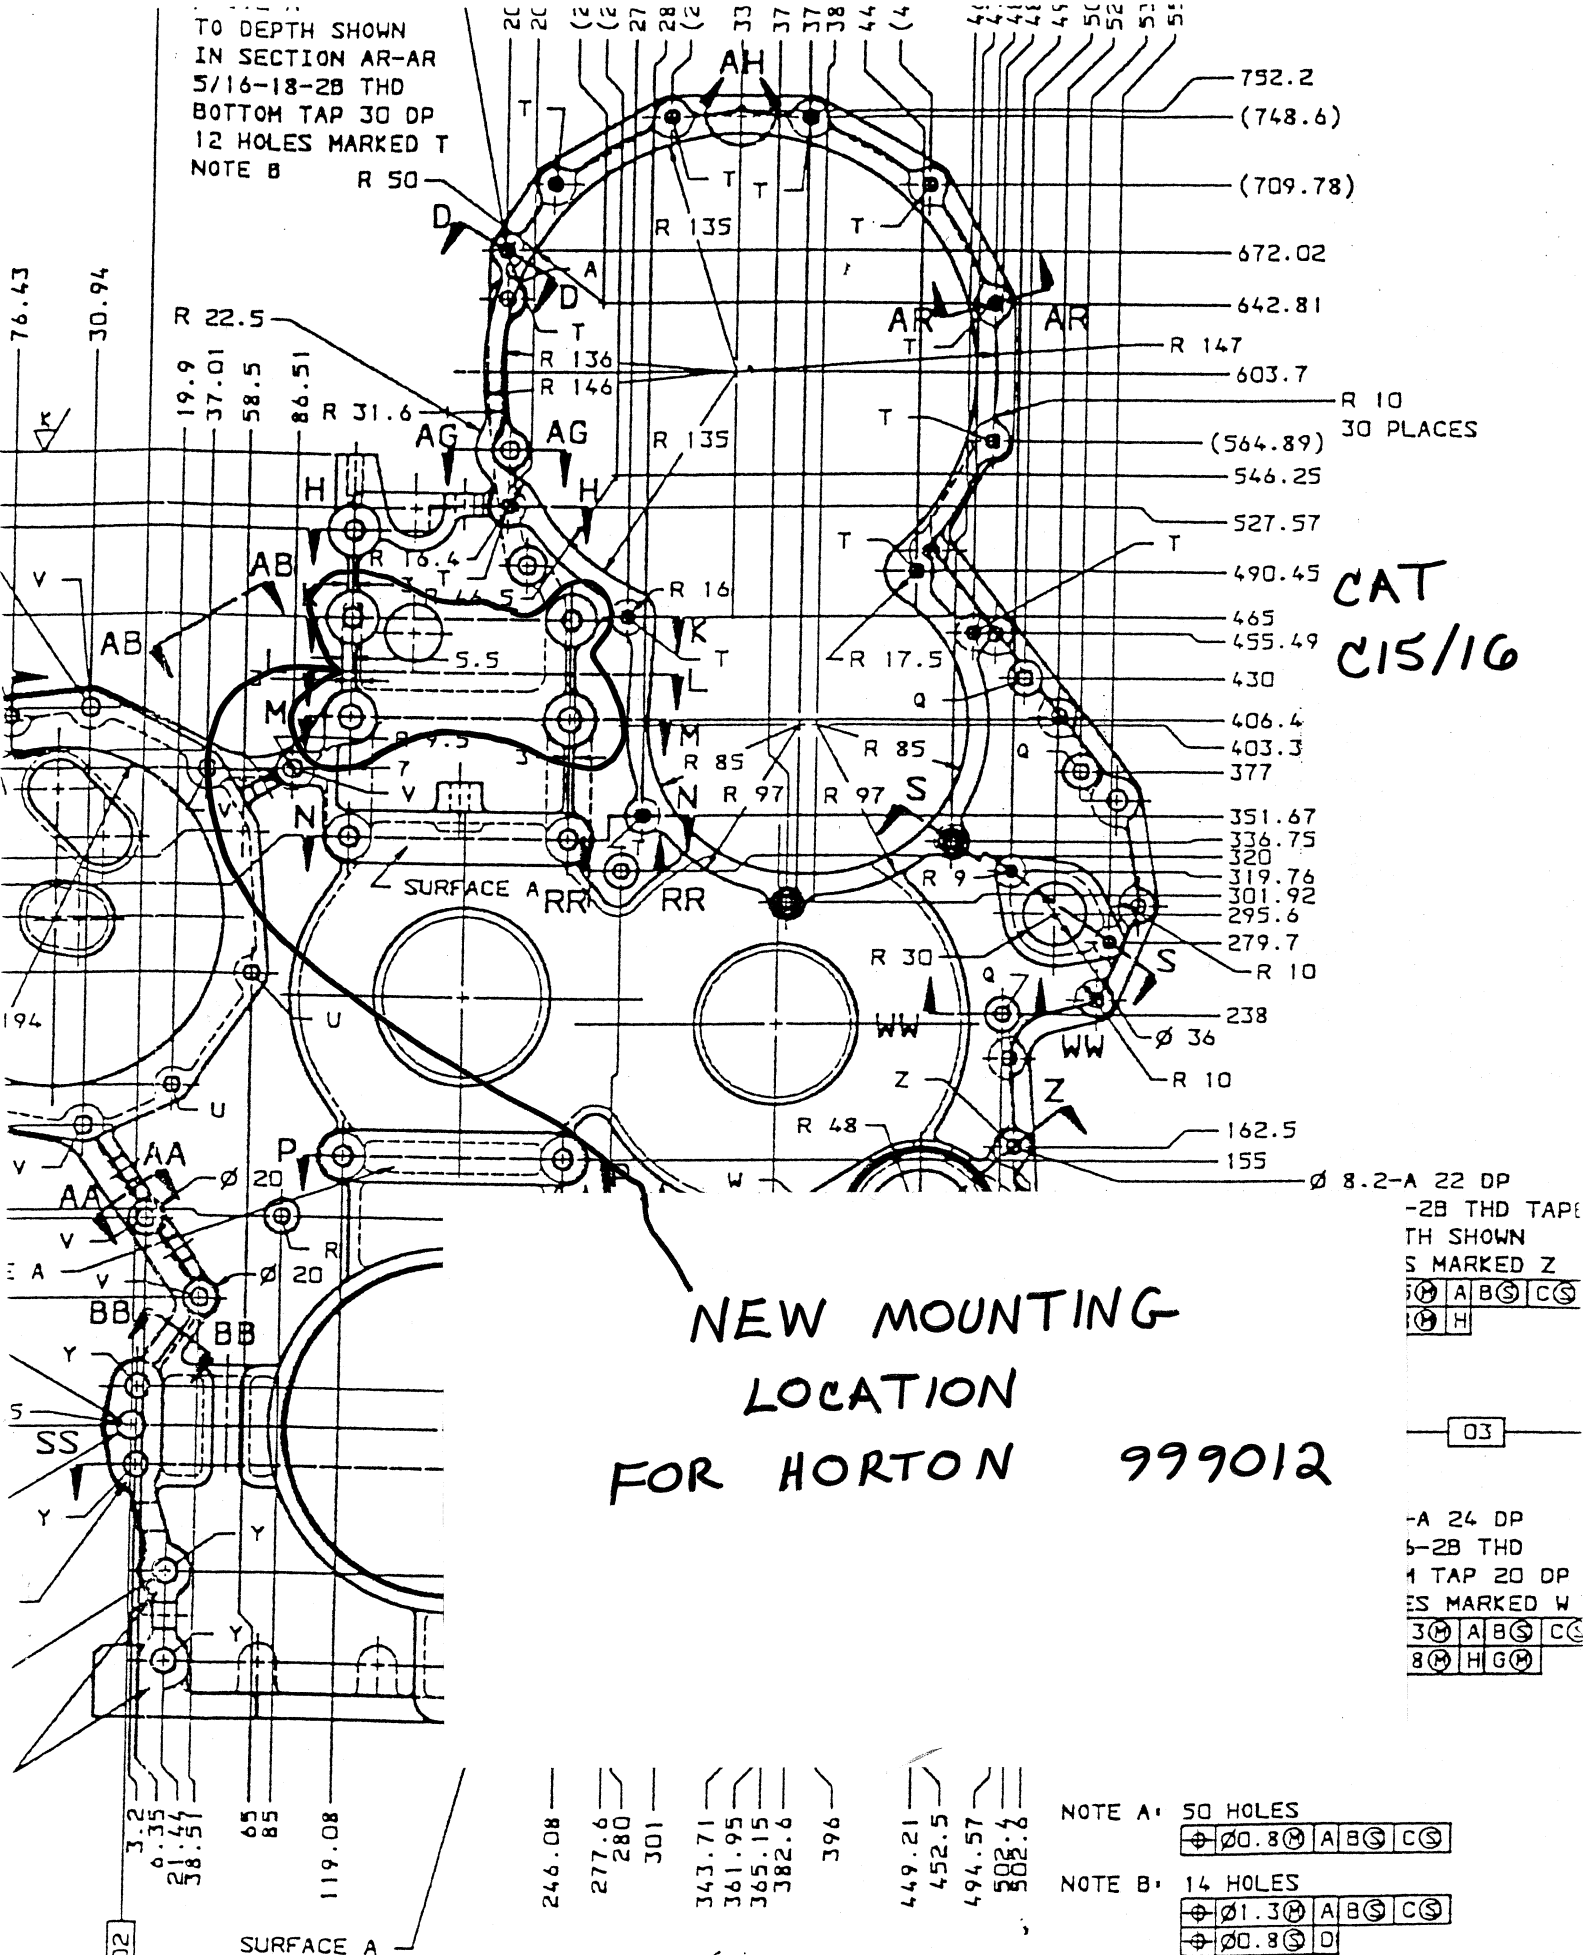
NEW MOUNTING  
LOCATION  
FOR HORTON 999012

In August of last year, per Peterbilt's request, Horton changed the journal bracket on the 999012. This was done so that during engine dress Horton and Borg-Warner fan drives would share the same engine mounting stud locations. The fan center did not change when the new journal bracket was implemented only the mounting location.

What mechanics are encountering during service is that the replacement fan drive has the new bracket, which uses different mounting holes on the engine.

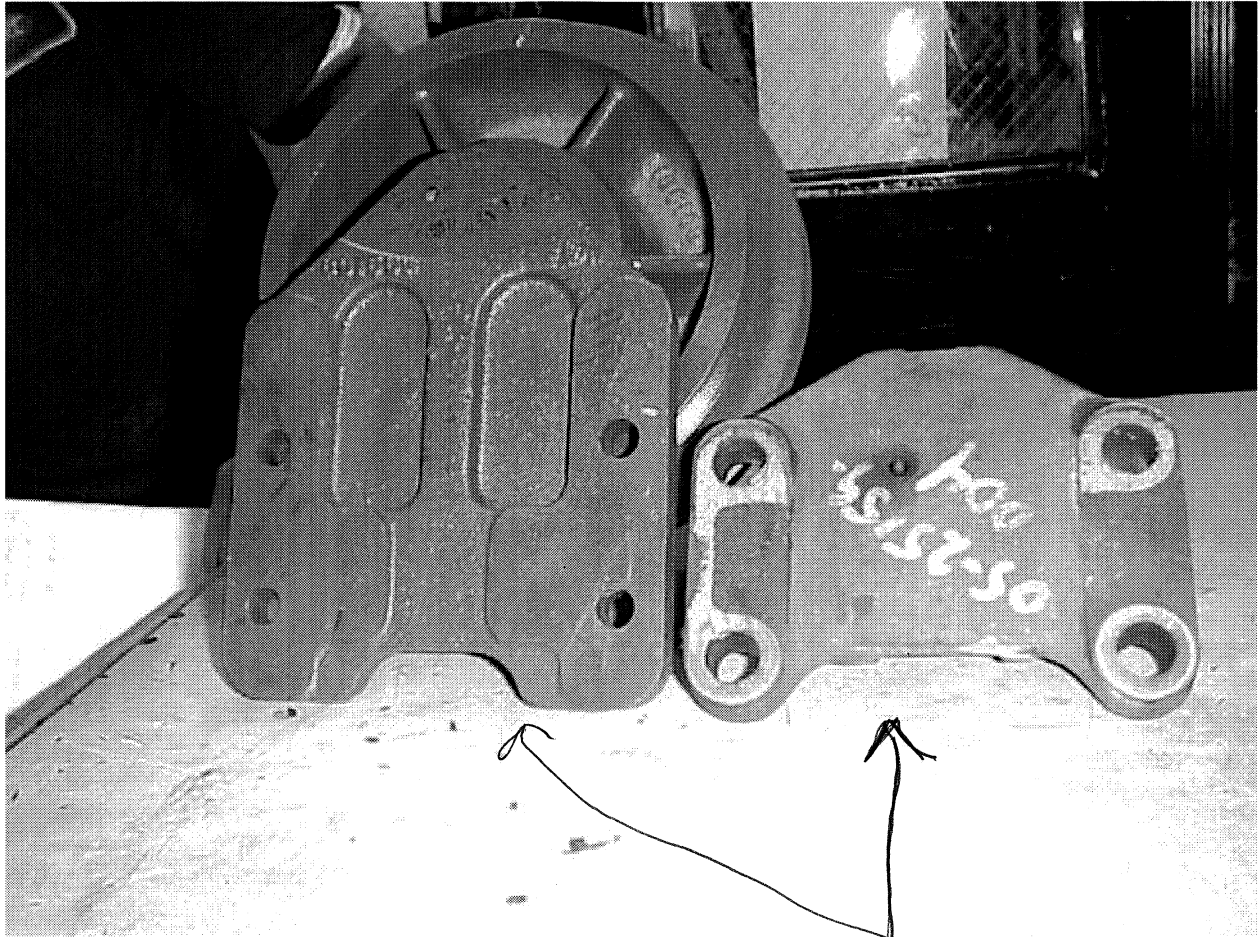
AUG 00 changed brkt. FROM TO.

NOW 14998

WAS 14766
