## **FAX TRANSMITTAL**

**Subject** Horton Drivemaster 989012/999012

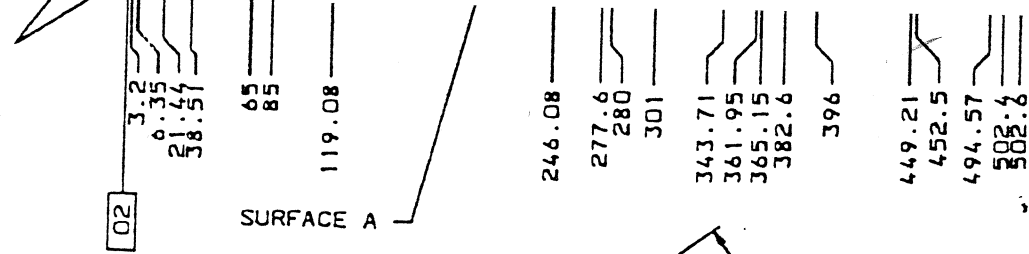
OLD MOUNTING  
 LOCATION  
 FOR HORTON 999012

DriveMaster 999012's built before Serial # 2790699 use the old bracket; therefore, replacement with current production 999012's requires relocating the engine-mounting studs. (See accompanying drawings for clarification)

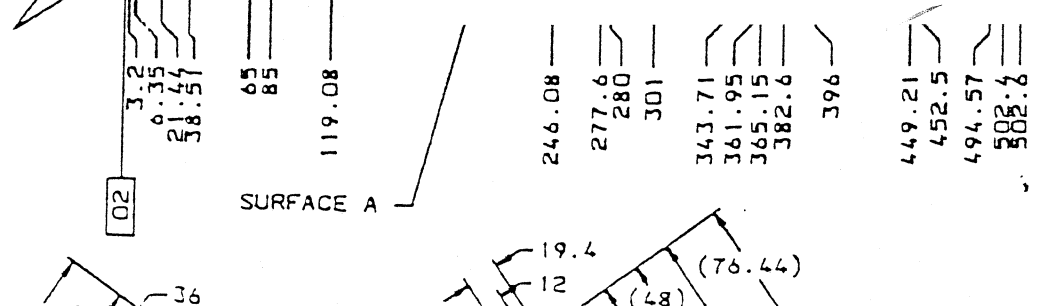
NEW MOUNTING  
LOCATION  
FOR HORTON 999012

What mechanics are encountering during service is that the replacement fan drive has the new bracket, which uses different mounting holes on the engine.
