# Eaton Hybrid Drive Systems MY09 TRTS2000 EN-US

October 2015

## MY09 PEC Models

## General Information

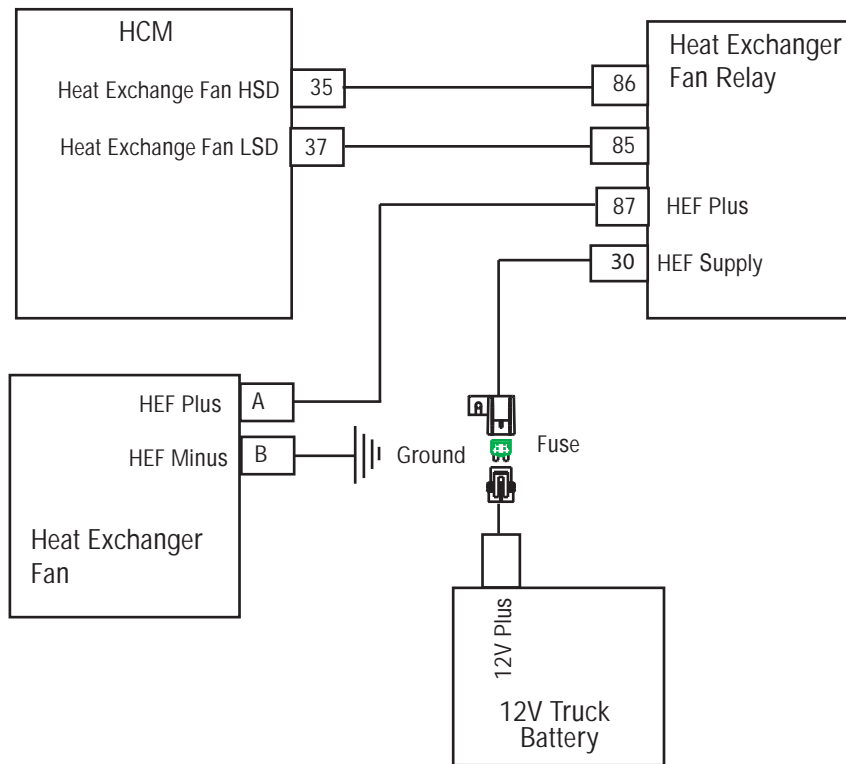
### Component Identification

- FMI 3, 4, 5
  - Vehicle Harness from HCM to Heat Exchanger Relay
  - Heat Exchanger Relay
  - HCM
  - Heat Exchanger Relay Fuse

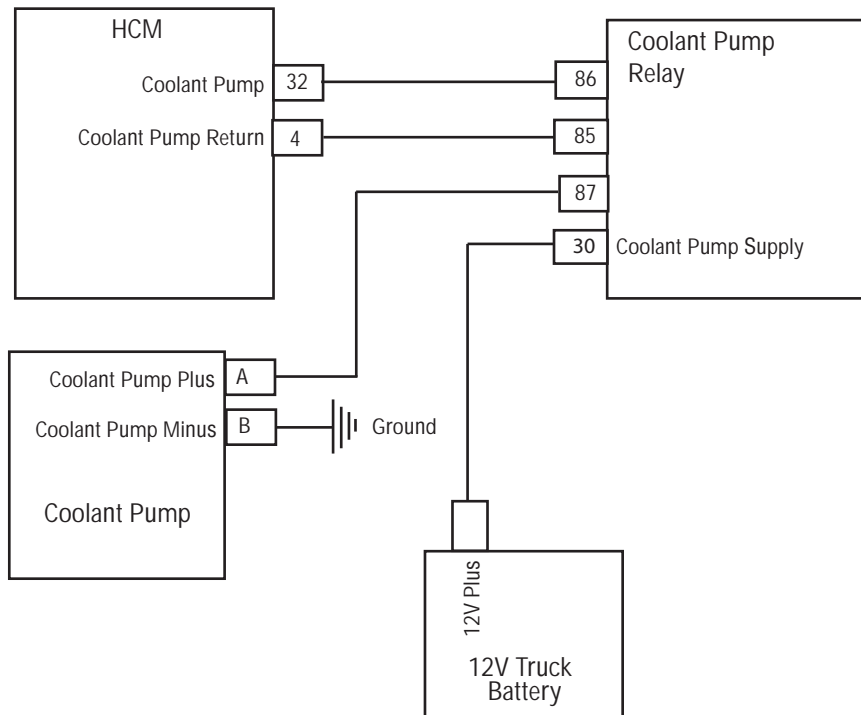
### Component Identification

- FMI 3, 4, 5
  - Vehicle harness from HCM to Cooling Pump Relay
  - Cooling Pump Relay
  - HCM
- FMI 14
  - Cooling Pump Relay
  - Cooling Pump
  - Cooling Pump Relay main power supply
  - Low coolant
  - Low coolant flow
  - Plugged radiator
  - Fan operation

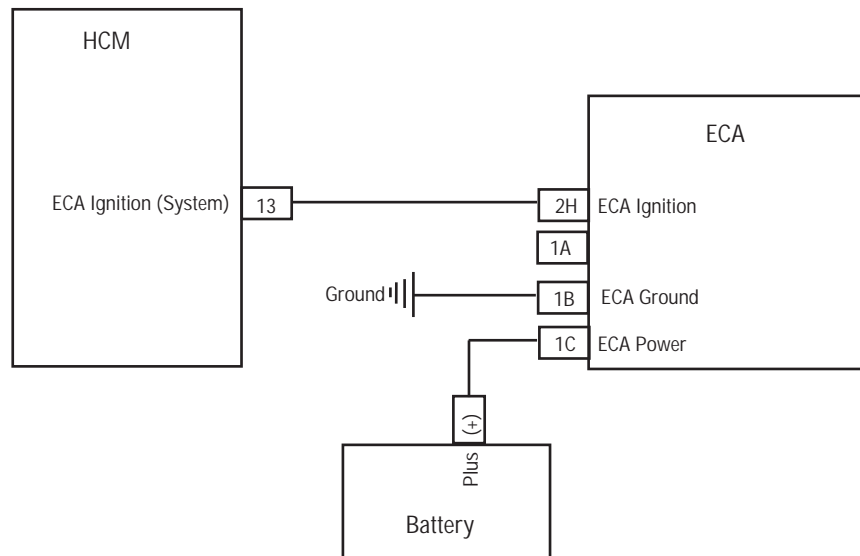
### Component Identification

- FMI 3, 4, 5
  - ECA ignition supply harness from HCM
  - HCM
  - ECA

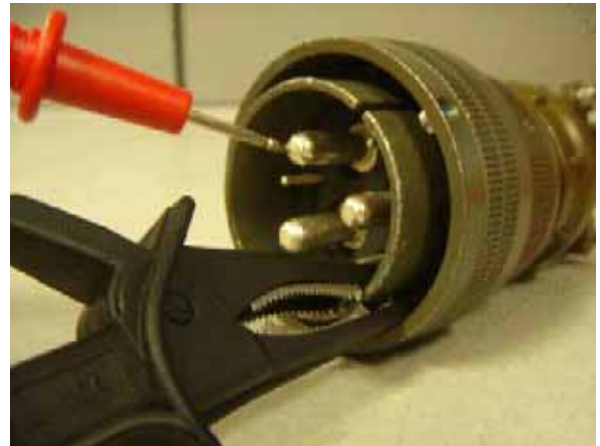
1. Retrieve Active fault codes and FMIs with ServiceRanger using the 9-Way Diagnostic Connector.
2. Which FMIs are present?
  - If Fault Code 18 is Active, go to "Fault Code 19 - CAN ECA Message Fault (HCM)" on page 101.
  - If Fault Code 18 is not Active, test is complete, go to **Step V**.

---

## Fault Code 18 - ECA Communication Fault

*Purpose: Check for Active or Inactive fault code status.*

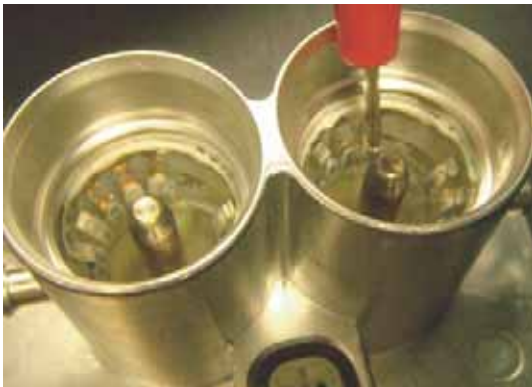
2. Measure the resistance within the Inverter positive to Case (Ground) on the Inverter High Voltage pins on the DC side.
  - Positive (+) to Inverter Case
  - Negative (-) to Inverter Case

- If open or OL, go to **Step H.**
- If resistance is 0-220K Ohms, replace the Inverter (see **MY09 Inverter Removal and Installation**). After repairs are made, go to **Step V.**

Connection	Measurement
Positive (+) to Inverter Case	
Negative (-) to Inverter Case

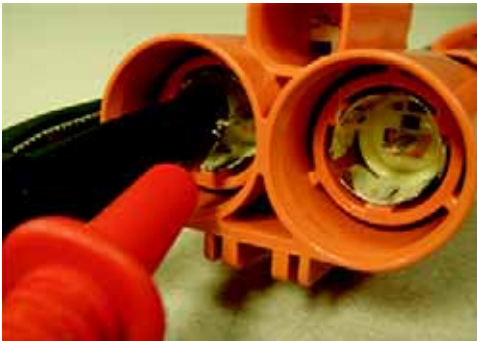
2. Disconnect the DC/DC High-Voltage Cable at the PEC.
3. Measure the resistance to ground at the DC Cable Connector on both the positive and negative terminals to shield:
  - Positive (+) to Cable Shield
  - Negative (-) to Cable Shield

- If any resistance is between 0-220K Ohms, go to **Step J**.
- If resistance is OL, replace the PEC. See the **MY09 Power Electric Carrier (PEC) Removal and Installation** procedure in TRSM2000 and perform repairs, then go to **Step V**.

Connection	Measurement
Positive (+) to Cable Shield	
Negative (-) to Cable Shield

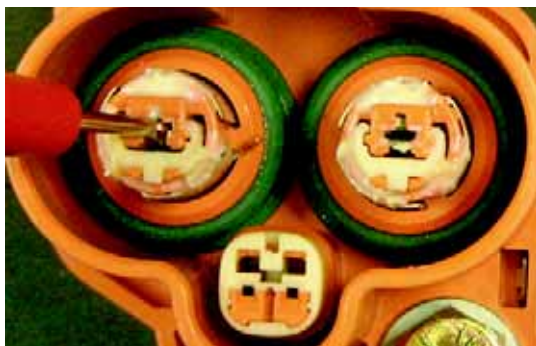
2. Disconnect the DC/DC High-Voltage Cable at the DC/DC Converter. The High Voltage DC Cable should be disconnected from the PEC and the DC/DC Converter.
3. Measure resistance on DC/DC Cable.
  - Positive (+) to positive (+)
  - Negative (-) to negative (-)
  - Positive (+) to shield ground
  - Negative (-) to shield ground
4. Measure resistance at the inverter
  - Positive (+) to DC/DC case
  - Negative (-) to DC/DC case
  - If resistance is OL, find error in testing, go to **Step I.**

- If resistance is anything other than OL, replace DC/DC Converter. See the **DC/DC Converter Removal and Installation** procedure in TRSM2000, then go to **Step V.**

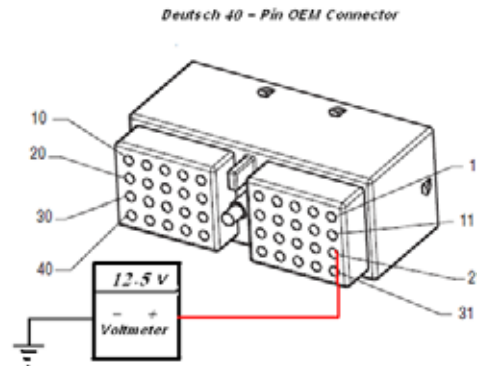
1. Key off, wait 1 minute.
2. Disconnect the 40-Way Inverter Connector.
3. Key on (this will set a Fault Code 88, clear fault after repairing).
4. On Vehicle Harness, check for any voltage on pins 21, 31, 22, 32, 23 and 33 to ground:

- If any voltage is found, remove 19-Way Connector on the PEC and recheck for voltage at Inverter 40-Pin, then go to **Step C.**
- If voltage is still present, repair Vehicle between Inverter and the 40-Pin, then go to **Step C.**
- If voltage is gone, go to **Step C.**

Connection	Measurement
Pin 21 to ground	
Pin 31 to ground	
Pin 22 to ground	
Pin 32 to ground	
Pin 23 to ground	
Pin 33 to ground

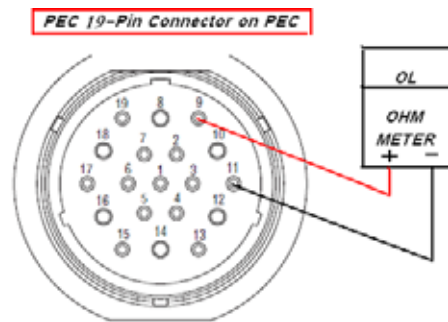
1. Key off.
2. Disconnect the PEC 19-Way Connector. (Red Service Button on PEC should be pulled out.) (Do not perform "Hybrid Shutdown Procedure" yet.)
3. Measure resistance on the PEC Connector:
  - Pin 9 to Pin 11
  - Pin 13 to Pin 15
  - Pin 17 to Pin 19

- If the resistance between Pin 9 and Pin 11, and Pin 13 to Pin 15 are each 33–37 ohms and the resistance from Pin 17 to Pin 19 is 112–122 ohms, go to [Step G](#).
- If any resistance is outside of range, reset the Inertia Switch located inside air filter opening or in Rear Access Panel by the High-Voltage Fuse. See the [MY09 PEC Inertia Switch Reset Procedures](#) procedure in TRSM2000, then go to [Step V](#).

Connection	Measurement
9 to 11	
13 to 15

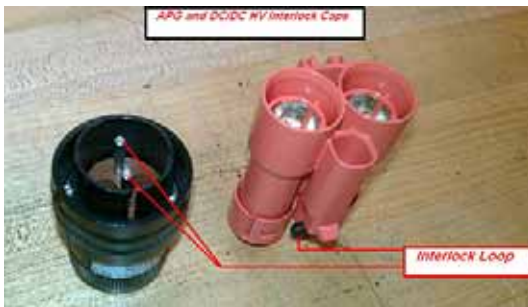
1. Key off.
2. If vehicle is equipped with Export Power PEC, perform “High-Voltage Service Shutdown and Power-Up Procedure” on page 4, then remove High-Voltage DC/DC and/or APG High-Voltage Cable from the PEC. Install Interlock Caps if available:
